**National Highway
Traffic Safety
Administration**

Case Vehicle (A): 1999 Chevrolet
Type: Venture 4 x 2, 4-door APV
Driver: 18-year-old male
CDC: 12-FREE-5, 09-LZAW-4

GENERAL VEHICLE DAMAGE AND ESTIMATED CRASH SEVERITIES

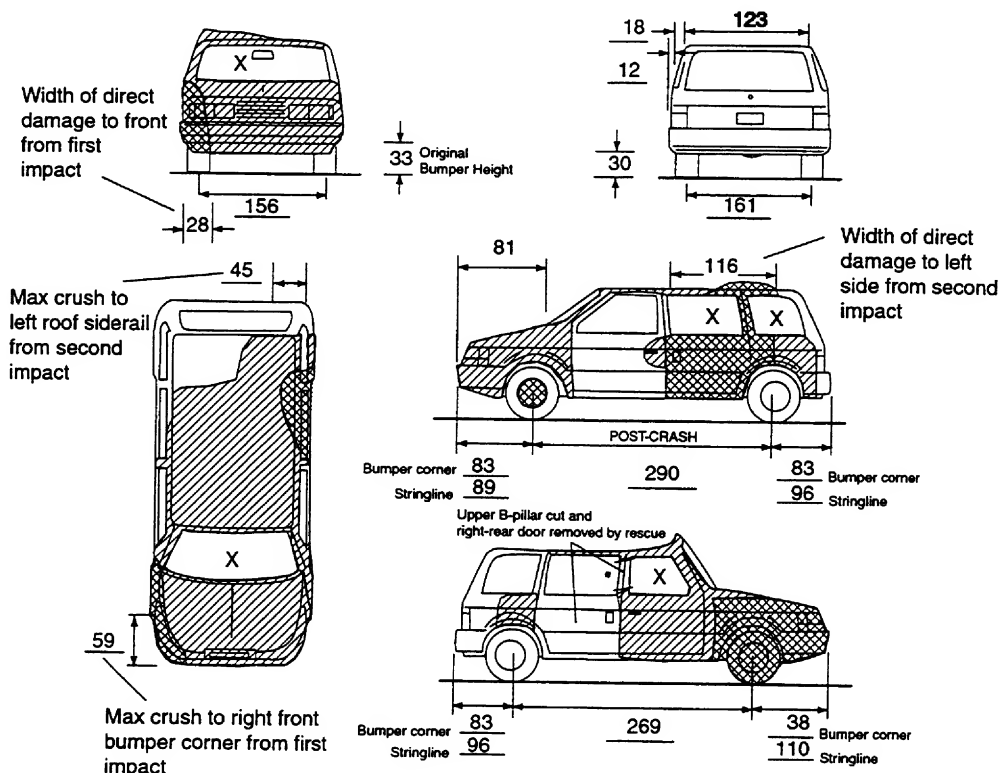
VEHICLE DAMAGE

(Slide 14) Damage to case vehicle (A) was severe. The right front of the vehicle was severely crushed rearward from the first tree impact. (Slide 15) Direct damage from the frontal impact began at the right bumper corner and extended 28 cm to the left, resulting in 22-percent vehicle overlap. (Slide 16) The maximum crush was 59 cm to the right-front bumper corner. (Slide 17) Damage to the left side of case vehicle (A) was moderate. Direct damage began 73-cm forward of the left-rear bumper corner and extended 116-cm forward along the quarter panel. (Slide 18) The maximum crush from this side impact was 45 cm to the left roof siderail.

Direct Damage Length (DDL) 028 cm
35 37

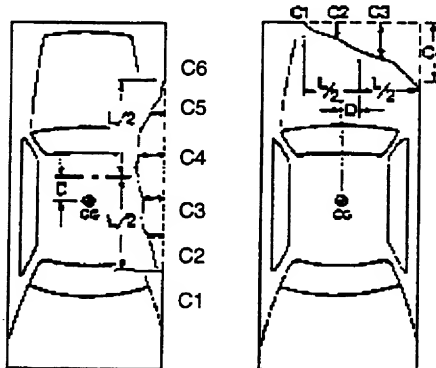
CRUSH PROFILE IN CENTIMETERS

DL 28
UDL 132

Specific Impact Number	Plane of Impact C-Measur.	Direct Damage		Field L	C ₁	C ₂	C ₃	C ₄	C ₅	C ₆	±D
		Length (DDL)	Max Crush								
1	1	28	72	112	6	9	15	26	36	72	+66
-	Free space		-13		-13	-4	-1	-1	-4	-13	
1	1	028	059	112	000	005	014	025	032	059	+066
13	14	15 16 17	18 19 20	21 22 23	24 25 26	27 28 29	30 31 32	33 34 35	36 37 38	39 40 41	42 43 44 45
2	4	116	45	192	0	9	16	29	14	0	-96
	4							45			
	Average							37			
2	4	116	045	192	000	009	016	037	014	000	-096

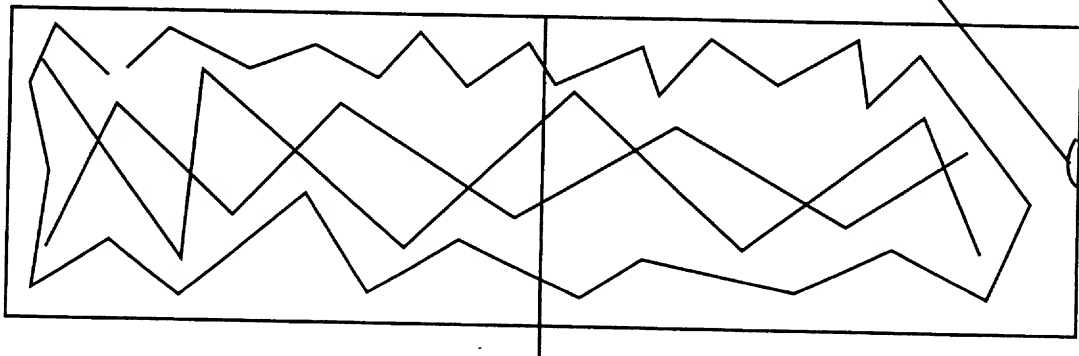
Small amount of bond separation
 less than 1% of total

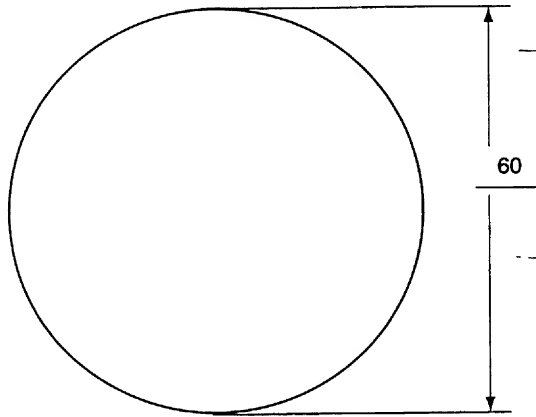
Driver Airbag

This vehicle was equipped with (slide 43) steering-wheel and (slides 44 and 45) passenger frontal-impact airbags, and both deployed during the frontal impact. (Slides 46, 47, 48 and 49) There was no damage to the module flaps/covers of either the steering-wheel or (slides 50 and 51) the passenger airbag modules. (Slide 52) The passenger airbag module cover contacted the windshield and there were some small holes in the passenger airbag fabric from the broken windshield glass. This vehicle was equipped with driver and (slide 53) passenger side-impact airbags which were located in the outboard side of the seatback, but none of these airbags deployed. (Slide 54) There was no damage to the steering-wheel rim or (slide 55) spokes. There was no apparent vertical displacement of the steering column, but the steering column was deflected to the left. Also in the front, (slide 56) the upper, mid, and lower instrument panels, control knobs, (slide 57), windshield top molding, (slide 58) rearview mirror, upper vent outlets, heater/ac ducts, control knobs, (slide 59) radio, and (slide 60) glove compartment were damaged. The glove-box door was removed post-crash in order to access the event data recorder.

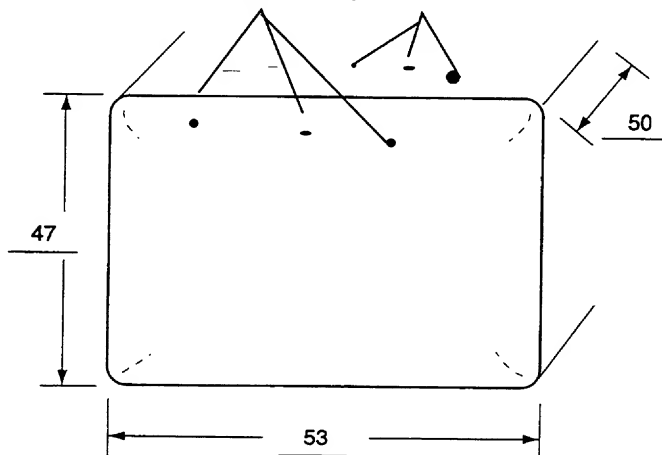
Passenger Airbag

Multiple small holes in airbag fabric from broken windshield glass

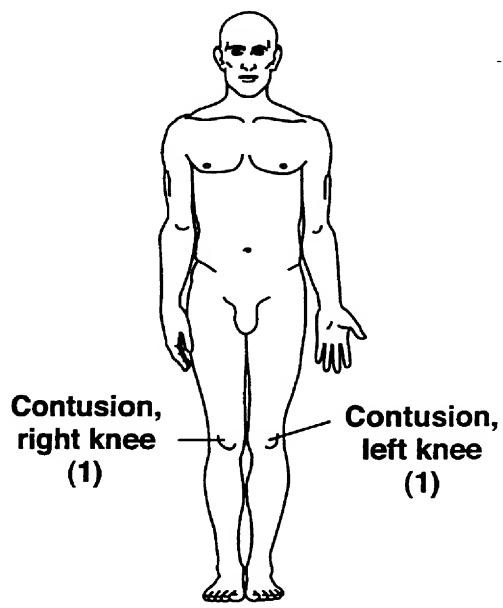
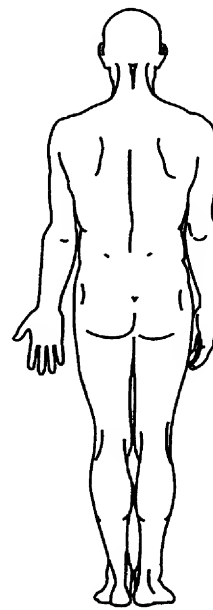
INDICATE LOCATION OF INJURIES.

Injury Description	A.I.S.	Injury Source		
		Definite	Probable	Possible
Contusion, right knee	1	Knee bolster		
Contusion, left knee	1	Knee bolster		
<u>Maximum A.I.S. Level</u>	<u>1</u>			
<u>Injury Severity Score</u>	<u>1</u>

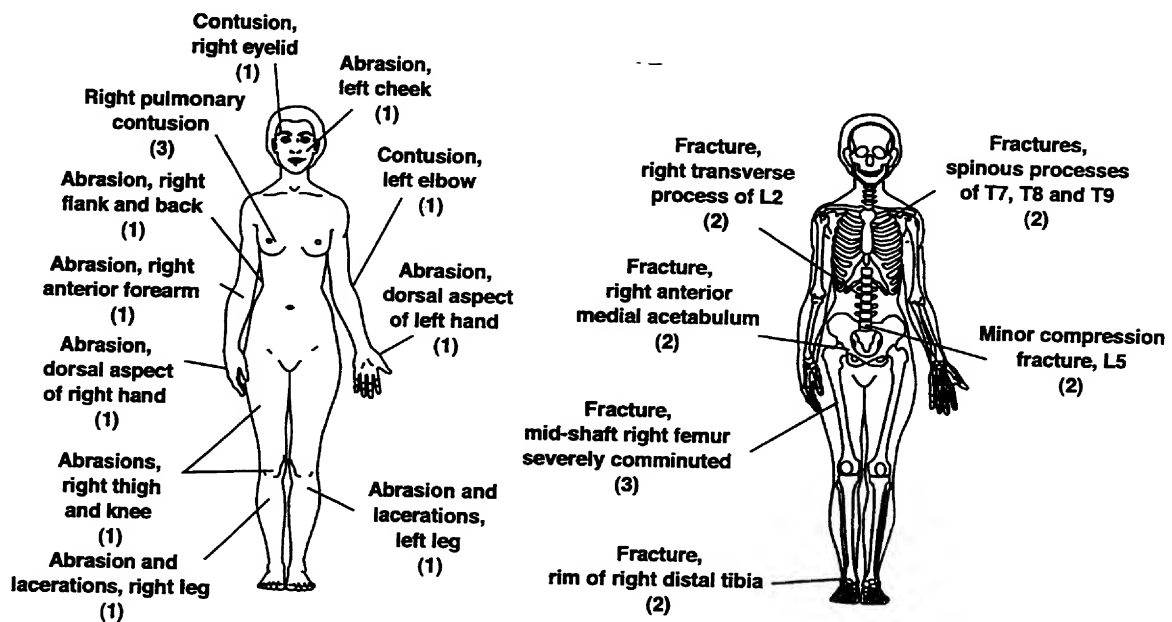
INDICATE LOCATION OF INJURIES.

Injury Description	A.I.S.	Injury Source		
		Definite	Probable	Possible
Contusion, right eyelid	1			Airbag
Abrasion, left cheek	1			Airbag
Right pulmonary contusion	3			Door
Fractures, spinous processes of T7, T8 and T9	2		Impact force (twisting and flexion)	
Fracture, right transverse process of L2	2		Impact force (twisting and flexion)	
Abrasion, right flank and back	1			Seat back, seat cushion
Contusion, left elbow	1		Glove box	
Abrasion, right anterior forearm	1			Unknown
Abrasion, dorsal aspect of right hand	1			Unknown
Abrasion, dorsal aspect of left hand	1			Unknown
Minor compression fracture, L5	2		Knee bolster/ glove box	
Fracture, right anterior-medial acetabulum	2		Knee bolster / glove box and door interior	
Fracture, mid-shaft right femur severely comminuted	3		Knee bolster / glove box

Injury Description	A.I.S.	Injury Source		
		Definite	Probable	Possible
Abrasions, and lacerations, right leg	1			Knee bolster / glove box
Fracture, rim of right distal tibia	2			Right-front occupant's left leg
Abrasions, and lacerations, left leg	1			Knee bolster / glove box
Abrasions, right thigh and knee	1			Seat cushion
<u>Maximum A.I.S. Level</u>	<u>3</u>			
<u>Injury Severity Score</u>	<u>22</u>
